CUSTOMER COMPLAINTS

Remington Production Document Bates # R2500597 –R2500627

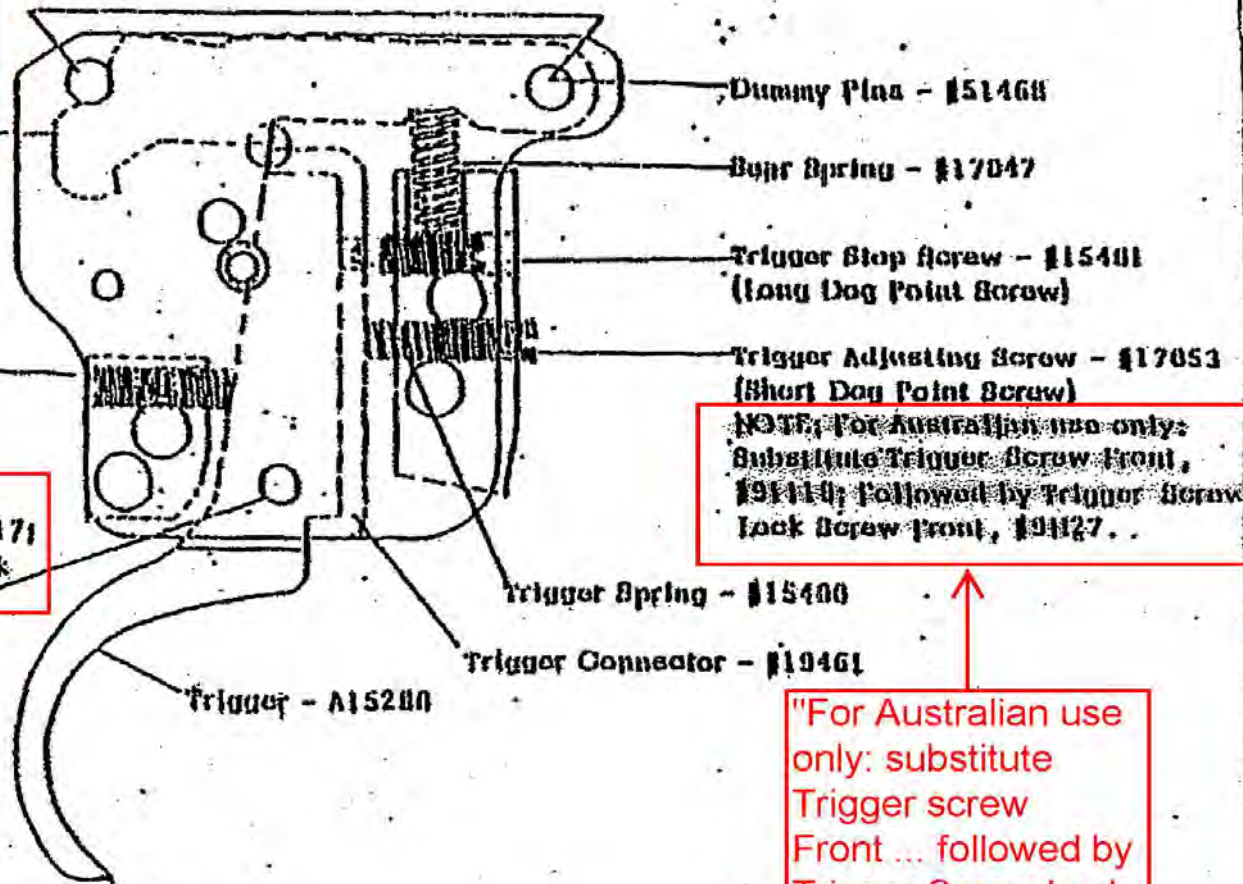
Trigger Pin #24477

NOTE: For Left Hand Version,
 substitute
 a Trigger Housing Assembly
 #12905

NOTE: For Australian use only:
 Substitute Trigger Screw Front,
 #91119, followed by Trigger Screw
 Lock Screw front, #91127.

Remington modified the trigger mechanism of the Model 700 by adding a trigger screw lock screw to prevent improper adjustment of the trigger for rifles exported to Australia. Remington failed to make this change on rifles that stay in the United States.

"For Australian use
 only: substitute
 Trigger screw
 Front ... followed by
 Trigger Screw Lock
 Screw."
